Minera Canasil, S.A. de C.V.

NORA PROJECT

Durango, Mexico.

PLANNED DDH 20A AND 20B

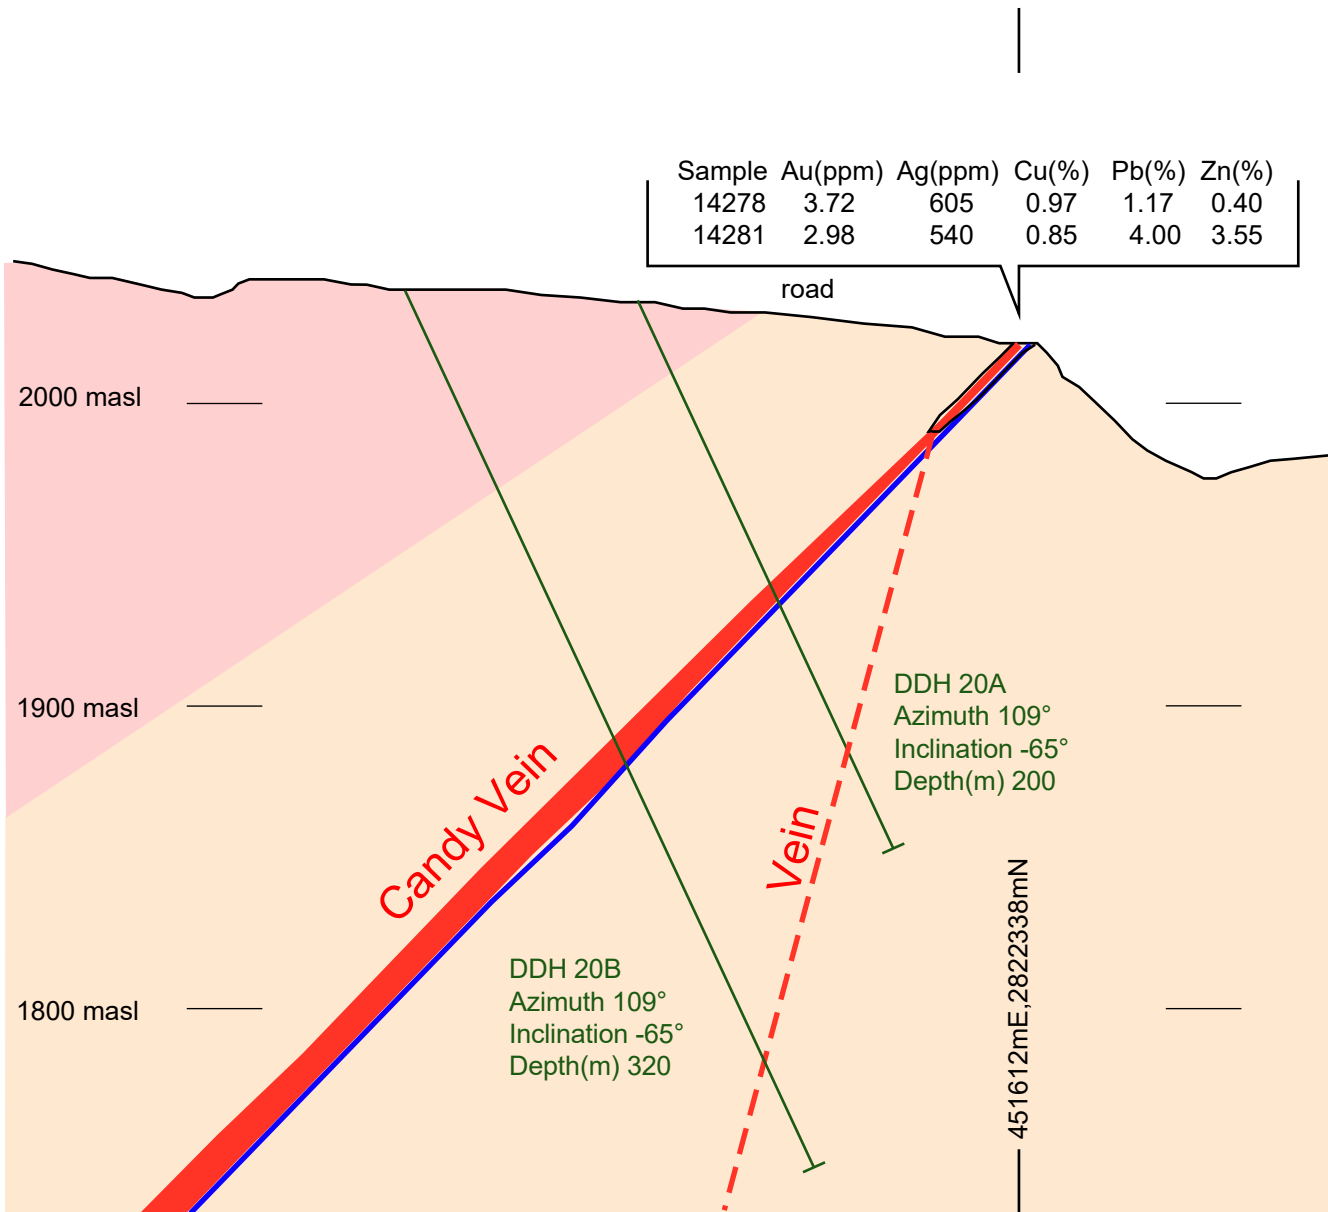
Looking to 19° NE

Sample	Au(ppm)	Ag(ppm)	Cu(%)	Pb(%)	Zn(%)
14278	3.72	605	0.97	1.17	0.40
14281	2.98	540	0.85	4.00	3.55

Mainly Ignimbrites densely welded pink to orange color.
-

Epiclastic massive breccias.
